CONDENSER REFURBISHMENT

TEi YIMPACT CARRY OUT MAIN STEAM TURBINE CONDENSER REFURBISHMENT PROJECTS AT TWO OF THE LARGEST CCGT POWER STATIONS IN THE UK.

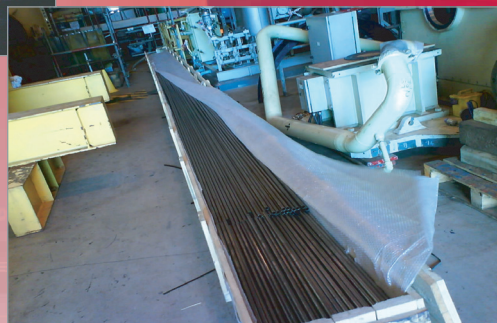
Replacement Tube supply

- Tubes sourced in 5 days from
Mainland Europe
- Cut to size in UK
